Wearing Its Age Lightly

The Library of Parliament is the single most exuberant expression of high Victorian spirit in Canada. In 2006, it took a new lease on life **By Janet Uren**

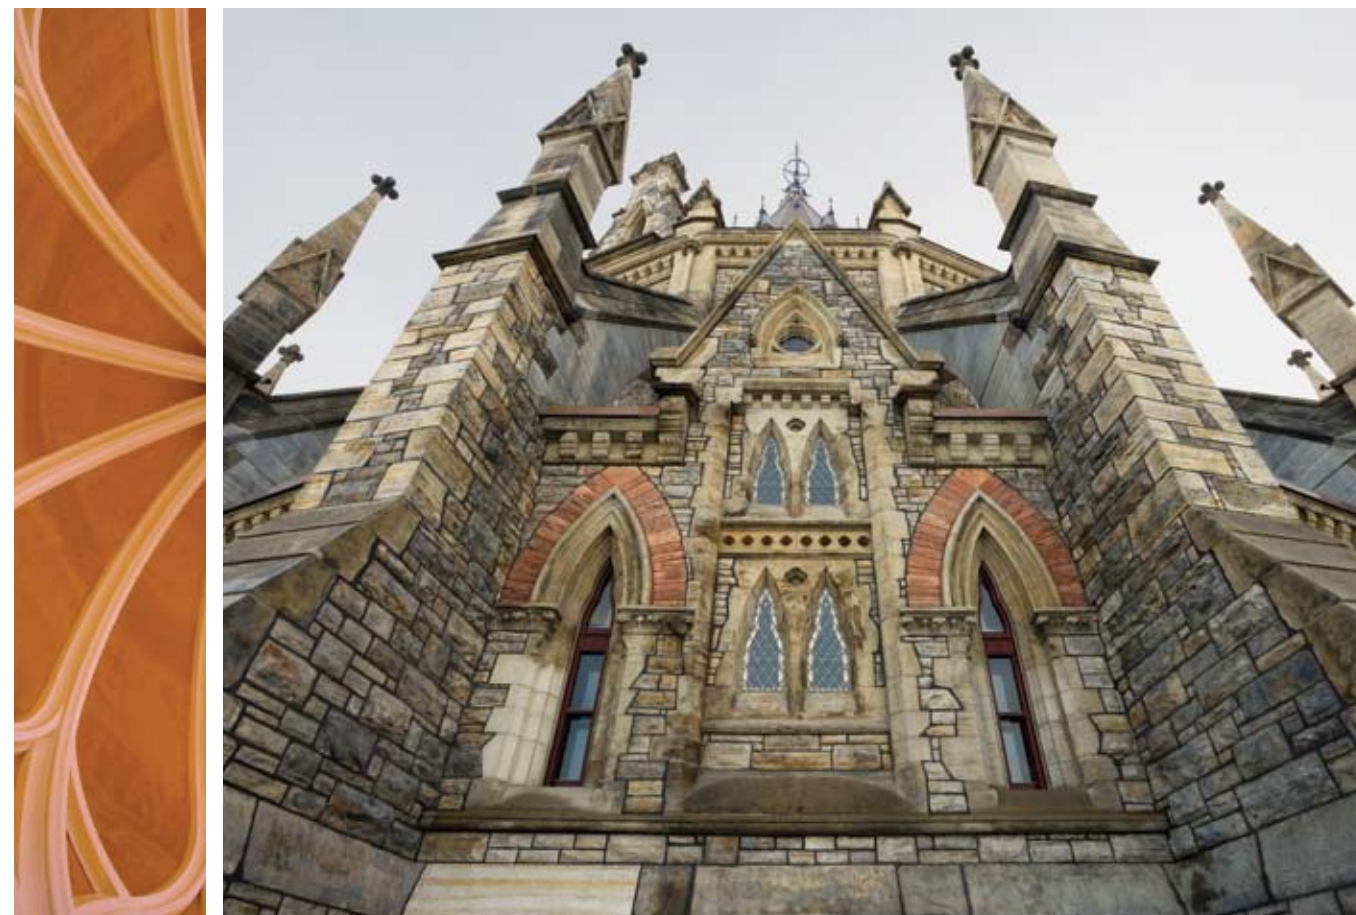
Window treatment: No more drafts! Librarians rejoiced as the 147 leaky leaded windows were restored

No major work was done over the next half century, and even without another fire, the building began to creak with age. The seams in the copper roof gaped. The glorious leaded windows shrank in their frames and began to leak water and cold air. When it rained, buckets collected drips in the attic and librarians ran to pull plastic sheets over the precious books. Those same librarians wore coats as they worked in winter.

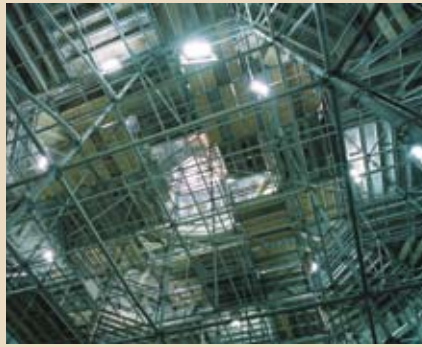
▲ The Scaffolding

It was no ordinary project. Contractors had to respect the working of Parliament, so they scheduled much of the noisiest work for nighttime, with shutdowns for national ceremonies. The Institute for Research in Construction came on board and, using an impact echo system, charted voids and cracks in the walls and measured how well the outer sandstone was adhering to the rubble core. Their findings showed that much of the interior grout had washed away and that earlier attempts at repair had been temporary fixes at best. In fact, the building was in much worse shape than anyone had ever suspected. Before work could begin, the team needed to create a working platform that would not damage those vulnerable walls. The result was some very creative self-sustaining scaffolding—70 tonnes of it, 17 storeys high—covered with tarps so that stone-masons and carpenters could labour summer and winter for four years.

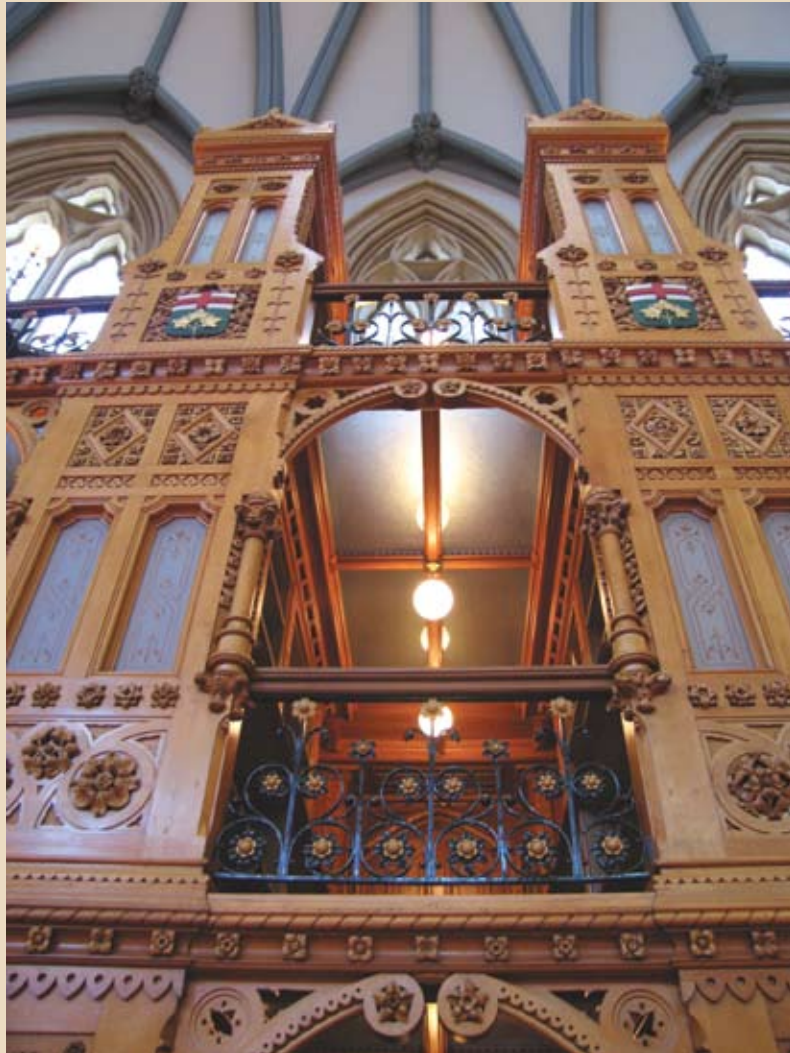
▲ The Galleries

In the old days, light came through the windows in the dome so strongly that librarians in the central area practically needed to wear visors. Other parts of the library—notably the third gallery—lay in almost unbroken gloom, and librarians went there armed with flashlights. Though the old gas lamps that line the galleries were wired for electricity long ago, they were overshadowed by the addition of hideous plastic shades in the 1950s. Today the lights have been restored with beautiful glass globes that cast an enchanting light over the whole space. The restorers of the 1950s also replaced the glass floors of the gallery with plywood and linoleum and painted the deeply coloured railings an unrelieved black. Today the floors and partitions of the galleries are once again constructed of light-disseminating glass. Traces of original paint also gave restorers the clue they needed to return the railings to their previous sprightliness with green, burgundy, and yellow paint.

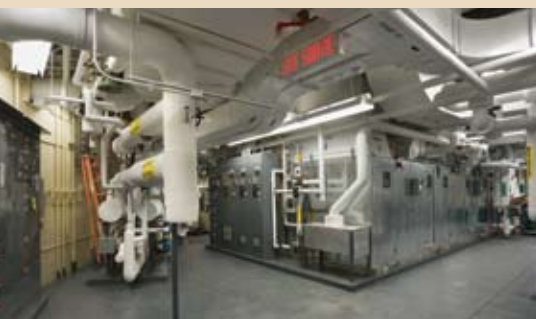
▲ The Basement

Hardrock miners rarely come to work in downtown Ottawa. For this project, however, they were hired to delve into the rock under the library and to create an extra 8.75 metres of new basement and a series of service tunnels. Again, the project called for innovation. While drilling and blasting may be fine for iron ore, they were out of the question with a fragile old building sitting right on top of the pit. The miners experimented cautiously with low-impact rock breakers and non-explosive dynamite. In the end, it was a new hydraulic rock splitter discovered at a trade show in Las Vegas that allowed the excavation to be made. The miners proceeded to remove some 4,815 cubic metres of rock, allowing for the creation of three basement levels. Gone are the low-ceilinged stacks. State-of-the-art air-conditioning and heating systems are now generously accommodated, and rare old books are protected as they should be.

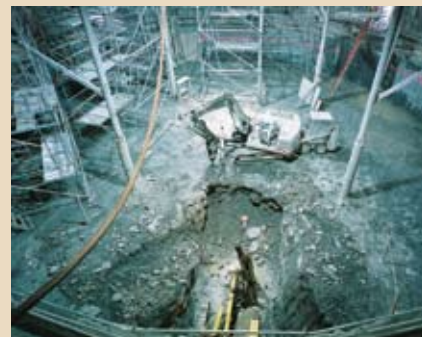
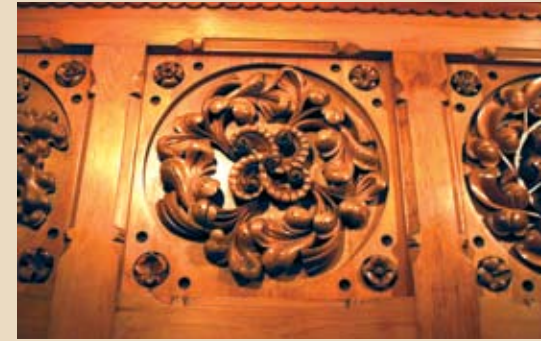
▲ The Woodwork

The carvings that line the walls of the library are one of its principal glories. A monument to the artistry and whimsy of the tradesmen who created the decorations in the 1870s, this fabulous wooden mosaic features a symphony of curling vines, bursting flowers, and fantastic animals and birds. No one panel is the same as any other. Many of the carvings were showing their age in the 21st century, but no attempt was made to make them look new. Teams of conservators went over every inch of them, cleaning and repairing major and minor damage and carving new pieces to replace damaged parts.

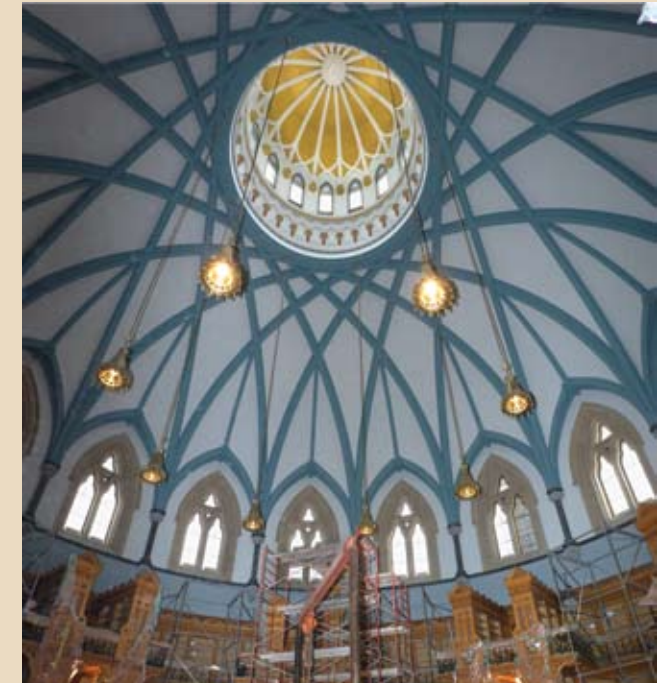
▲ The Dome (interior)

The Victorians loved bright colours. In the 1950s, however, much of the building's early splendour was buried under dull beige paint. As conservators and scholars studied the records and looked for traces of earlier colour schemes, they rediscovered some of the glory of the past and specified a new and brighter look for the old building. The ribs of the library vault, for example—once it had been cleaned and repaired—were outlined in rich blue, and the gold-leaf decoration was cleaned to restore its lustre.

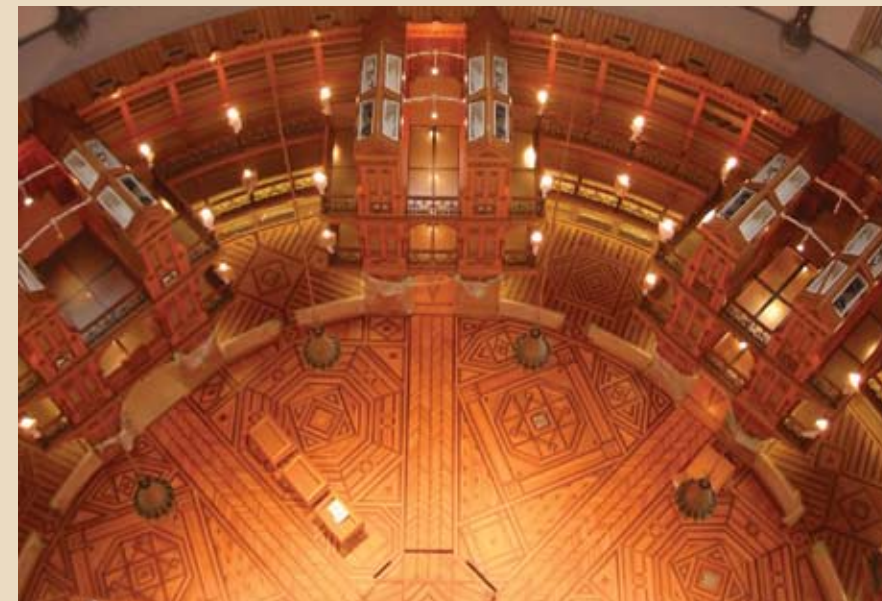
▲ The Floor

The floor installed after the 1952 fire was a glorious jigsaw of variously coloured woods, the contractor hired for that project being Montreal Parquetry. When the time came to replace the much-abused floor, the same company competed eagerly for the privilege of replicating the old splendour. Essentially, it undertook to recreate the floor of 1956 with three types of wood (oak, cherry, and walnut) in a complex geometric design. Because the building is not perfectly symmetrical—it was, after all, designed in the era before computer-aided design—the process of creating this huge wooden jigsaw took four months.

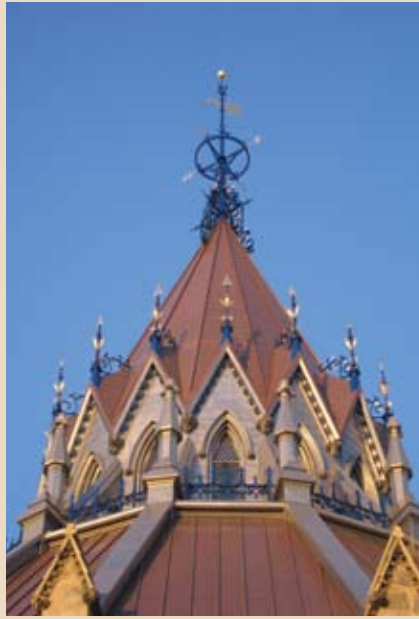
◀ The Dome (exterior)

The roof of the library is looking much cleaner and more colourful these days. The giant black weather vane, when dismantled, revealed tiny chips of blue and gold paint, and these inspired a new colour scheme for the restored vane. The roof also illustrates the continuity that persists among trades in this region and the pride they take in their work, generation after generation. The Fullers are just one case in point. When the dome of the library was recoppered, the old sheets of metal were shipped down the street to the new Canadian War Museum for reuse on three dramatic interior wall murals. One of the men hired to rehang the copper was startled to find a set of letters scratched on the back of one sheet. He realized that they were the initials of his uncle, who had worked on the library restoration in the 1950s.

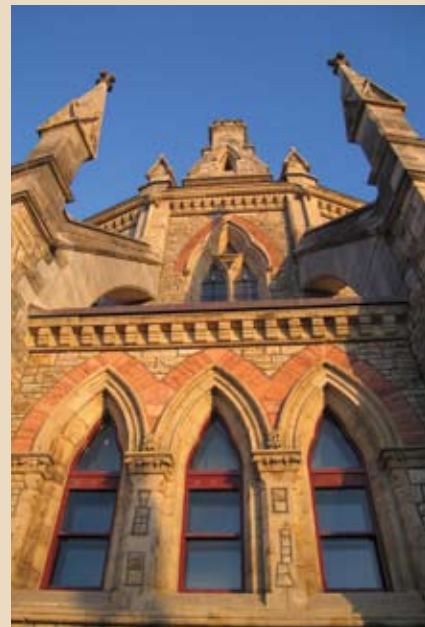
▶ The Windows in the Dome

Librarians of the future can put away their winter coats. Removing and restoring the 147 leaded windows was a headache, however, since many of the old comes, (slender bars of lead used to join panes of glass) fell to pieces in the hands of the restorers. The historic glass was carefully reassembled within the original design, with new comes, and every window was fitted with a second layer of energy-efficient thermal panes. This was anything but straight-forward, because the window embrasures all varied slightly in size, so custom-building of 147 windows would have been very costly. Instead, wherever possible, a standard window was used, with flexibly sized fittings around them. The windows were also fitted with heaters to keep the temperature constant and to prevent frost buildup.
